AFRL-PR-WP-TR-2002-2061

**JP-8+100 ENGINE DEMONSTRATION
Industry Version**

Final Report for 23 June 1995 – 30 July 2000

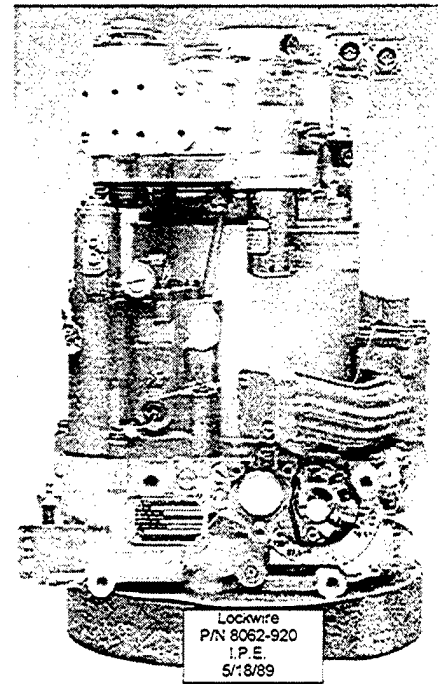
Figure 1 ESN 538103/5, 5A, 5B, and 5C Clean Layout Results: Main Engine Control

Observations: The MEC was found to be in generally excellent condition. It was very clean internally. Seals, O-rings, wear surfaces, and bearings exhibited no unusual wear or distress. No safety issues or early removal for cause were identified.

Disposition/Recommendation: Recommend that the MEC can be run for additional blocks of testing.

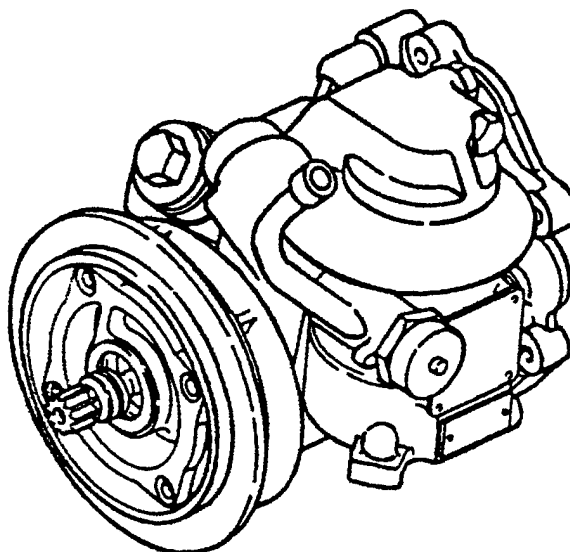
Figure 3. ESN 538103/5, 5A, 5B, and 5C Clean Layout Results: Main Fuel Pump

- No deterioration in performance.
- All elastomers in excellent condition.
- All parts in excellent condition except:
 1. Wear on filter bypass poppet seat not associated with JP-8+100.
 2. Impending bypass indicator would reset — not exposed to fuel.

- Reassemble pump. Return to Engineering Stores or engine operation.
- JP-8+100 fuel acceptance for Main Fuel Pump

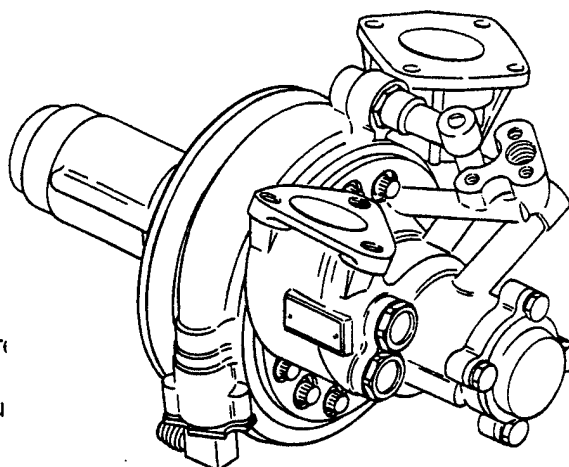
Figure 4. ESN 538103/5, 5A, 5B, and 5C Clean Layout Results: Augmentor Fuel Pump

- No deterioration in performance.
- All elastomers in excellent condition.
- All parts in excellent condition except inlet valve piston and stem damaged during disassembly.

- Reassemble pump and return to Engineering Store or engine operation.
- JP-8+100 fuel is acceptable for augmentor fuel pu

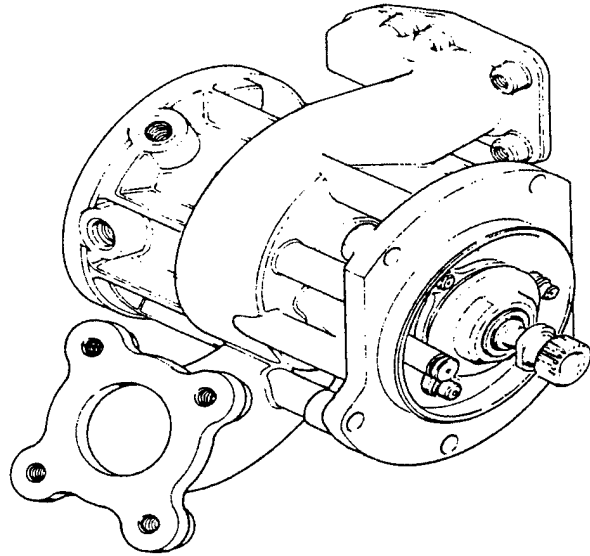
Figure 5 ESN 538103/5, 5A, 5B, and 5C Clean Layout Results: Fuel Boost Pump

Teardown is complete. All internal components are in excellent condition. There are indications of cavitation on "C" element blade tips, liner, and adjacent bearings.

- Wear measurements complete. All parts within T.O. limits.
- No degradation of elastomeric seals due to exposure to JP-8+100 fuel.
- One carbon seal broken during disassembly. No abnormal wear patterns observed.

- Rebuild pump and return to Engineering Stores.
- Fuel boost pump OK to use with JP-8+100 fuel.

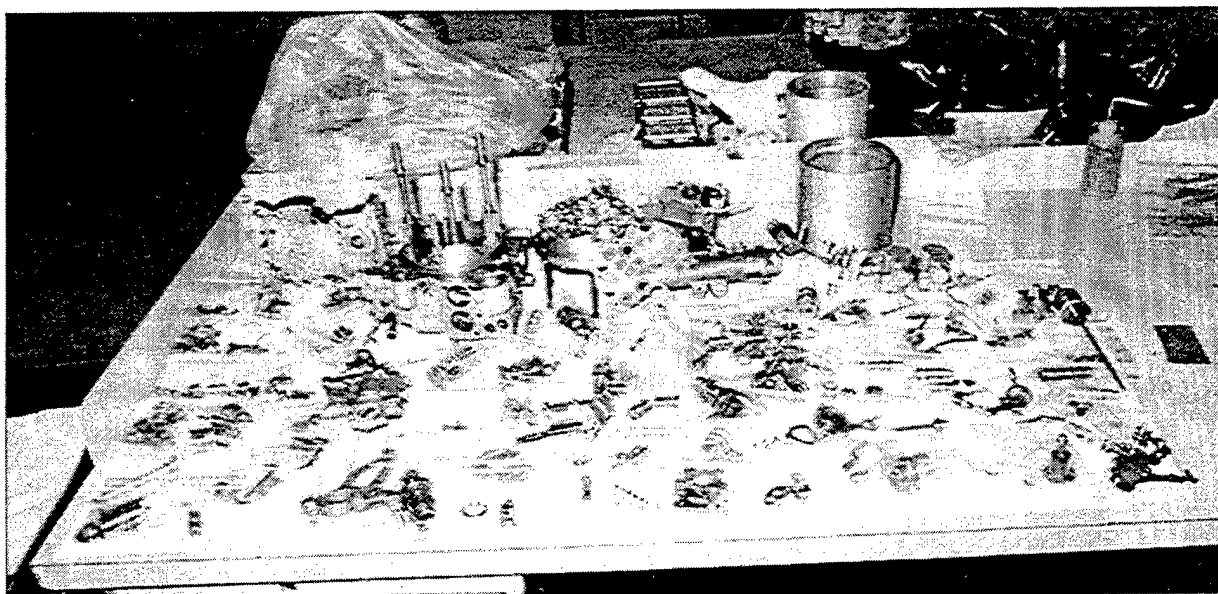
Figure 6 Main Fuel Control, Dirty Layout ESN 488109/6 - *Parts look very clean.*

Main Engine Control (MEC) - EOT at teardown was about 3699 hours. Internal and external leakage were within limits. Hardware was in very good condition overall. Normal handling damage was evident on external surfaces. Seals showed set expected for the operating time. The carbon bearings were in very good condition. Gears and bearings were serviceable. There were no hardware issues related to JP-8+100.

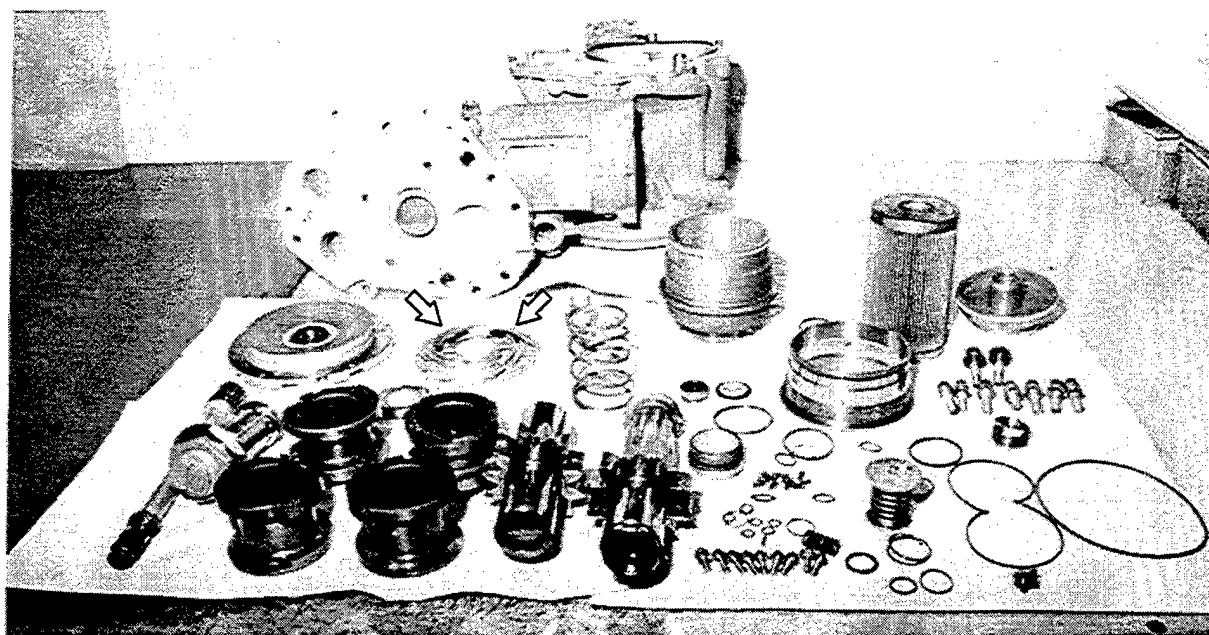
Figure 7. Main Fuel Pump, Dirty Layout ESN488109/6 - *Note chunks of rubber in impeller*

Main Fuel Pump - EOT at teardown was about 3010 hours. The overall condition was good. O-rings and seals were in very good condition (no distress); minor set was seen in some seals. Observed gear and bearing wear/cavitation and housing rubs were considered normal. Part No. 1973M67P08 (F110-129 Argo-Tech pump), which was new to the engine, was inspected to permit qualification of the fan engine.

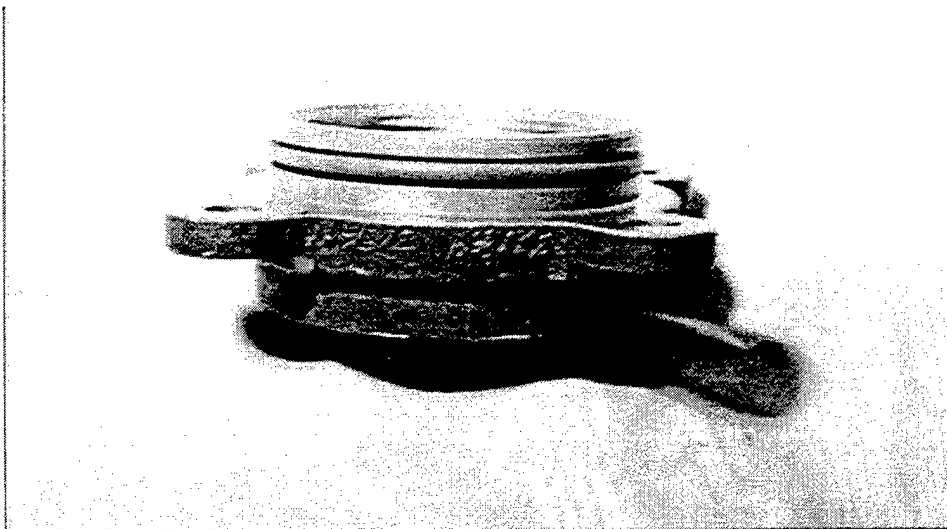
Figure 16 Typical O-Ring from Augmentor Fuel Pump *Little wear evident.*
